RECORDS

STEAM BOILER EXPLOSIONS,

EDWARD BINDON MARTEN,

MIDLAND STEAM BOILER INSPECTION AND ASSURANCE CO.

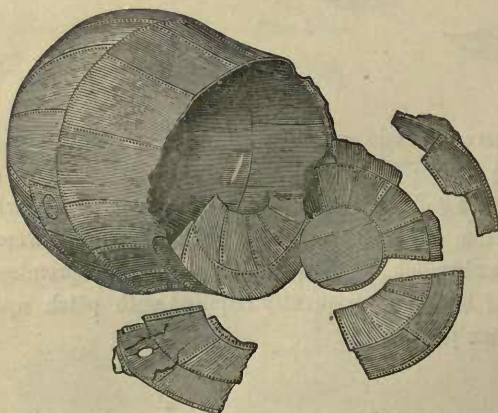
Fig. 30.

No. 34. Dudley. (*Fig. 30.*) June 25th.

One of two. Balloon, 34 years old, 12ft. diameter, 10ft. high,

$\frac{3}{8}$ inch plates, 7 lbs. pressure. There were no stays, and the boiler was of very weak shape, and as the boiler it worked with was loaded to 15 lbs., it is presumed this also was exposed to that pressure, and burst in consequence. It gave way at the angle at front over the fire, and was thrown over the engine house.

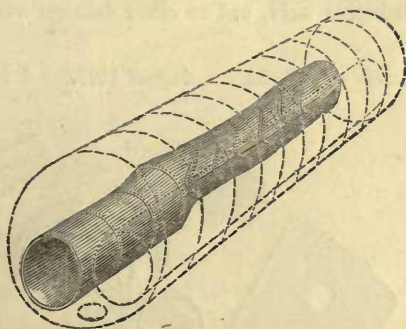
Fig. 31.

No. 35. *Manchester.* (Fig. 31.) *June 27th.* 2 killed, 1 injured.

One of four. Galloway, 4 years old, 32ft. long, 8ft. diameter, $\frac{7}{16}$ inch plates. Tube 2ft. 10in. diameter, originally intended for 40 lbs., but worked at 65 lbs. pressure. The left hand tube collapsed sideways, having been very much weakened by internal corrosion.

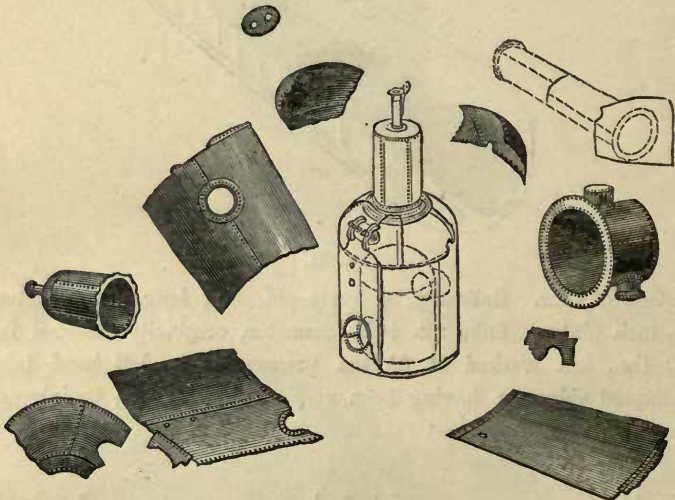
Fig. 32.

No. 40. *Leicester.* (*Fig. 32.*) *August 13th.* *4 killed, 5 injured.*

Upright Boiler, nearly new, 10ft. high, 5ft. diameter, with internal fire box, $\frac{1}{2}$ inch plates, 45 lbs. pressure. The shell was rent into many pieces, which were widely scattered, doing much damage. The safety valve was defective and incapable of relieving the pressure, and the spring indicated wrongly, so that a much higher pressure was used than the boiler could bear safely.

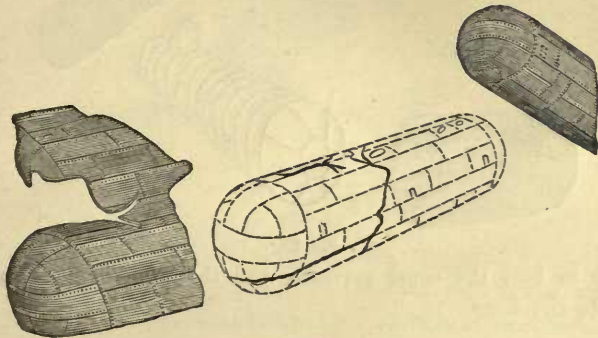
Fig. 33.

mechanically fired. It had just been extensively repaired over the fire, but it gave way at the back end, where a plate had been put in some time before, and it is supposed that a seam rip or injury to

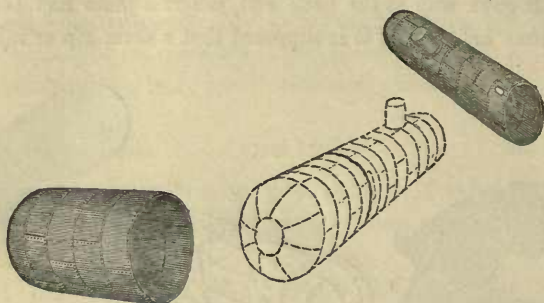
Fig. 35.

seam rip, caused by bad repair, had so far weakened it that it was

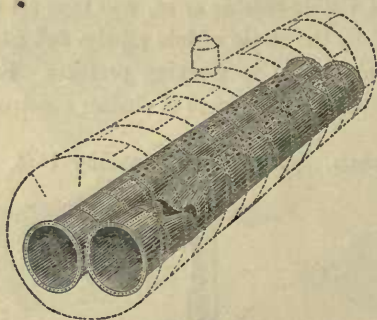
Fig. 36.

No. 44. *Exeter.* (Fig. 36.) *September 27th.* *1 killed.*

Lancashire, 2 years old, 31ft. long, 7ft. diameter, tube 2ft. 10in. diameter, with 56 Field tubes in each, $\frac{3}{8}$ inch plates, 45 lbs. pressure. The right hand tube collapsed and ruptured from softening of plates through shortness of water. The fire was blown out and set the premises on fire and much damage was done.

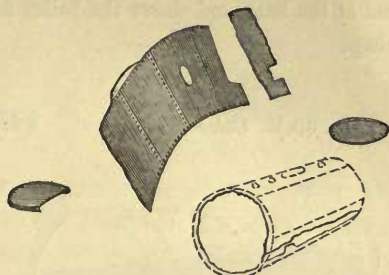
Fig. 37.

No. 46. *Liverpool.* (Fig. 37.) *October 4th.* 4 killed, 4 injured.

Plain Cylinder, 6ft. 6in. long, 3ft. 6in. diameter, $\frac{3}{8}$ inch plates, 80 lbs. pressure. The plates were corroded both inside and out, and in some places reduced to less than $\frac{1}{16}$ inch in thickness, and it was quite unfit to bear the ordinary pressure. The damage to the surrounding property was very great although the boiler was so small. The shell of the boiler was thrown across a street into an upper room of the house opposite.

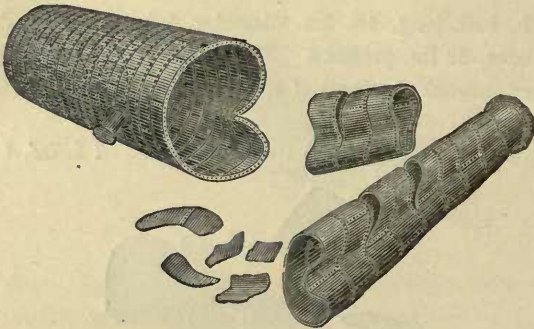
Fig. 44.

No. 54. Cornwall. (Fig. 44.) October 27th.

One of three. Cornish, 12 years old, 36ft. long, 6ft. diameter, tube 3ft. 9in. diameter, $\frac{3}{8}$ inch plates, 38 lbs. pressure. The tube collapsed from end to end, the front and central parts being blown out. The shell and back of tube were thrown in one piece to the rear, and much damage was done. It was supposed to have been short of water, because the tube had collapsed, but it is more likely it collapsed because of its weakness without strengthening rings. A tube in this boiler collapsed in a similar way about 5 years previously.

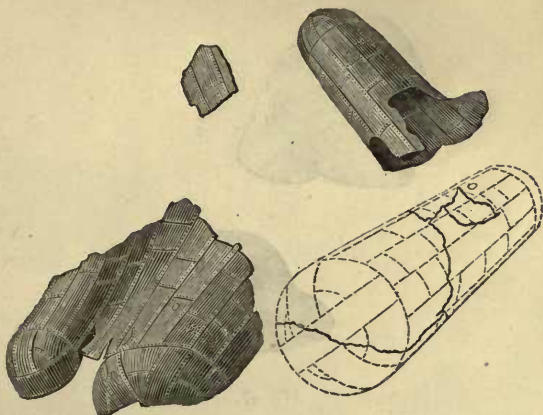
Fig. 45.

No. 55. Newcastle. (Fig. 45.) November 17th. 1 killed, 2 injured.

One of seven. Plain Cylinder, with plates arranged lengthways, 30 years old, 26ft. long, 6ft. diameter, $\frac{3}{8}$ inch plates, 35 lbs. pressure, mechanically fired. Gave way at a seam on the right hand side of the fire place, where the insertion of a new plate had caused injury to the old plate, and it divided into two parts which were sent in different directions. The uncertainty and treacherousness of these

straight seamed boilers has often been pointed out. See No. 41, and many examples in former years.

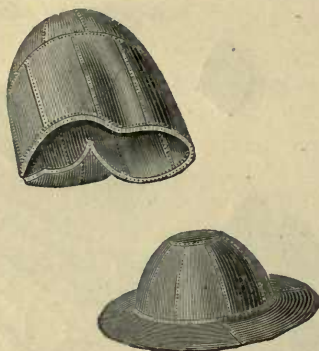
Fig. 47.

No. 58. *Manchester.* (Fig. 47.) *December 2nd.*

One of two. Balloon, used for evaporating only, nearly new, 9ft. high, and 9ft. diameter, $\frac{1}{2}$ inch plates, not usually worked at any pressure. The top was thrown 60 yards away, and the bottom left on furnace. The boiler was temporarily exposed to pressure which it was too weak a shape to bear.

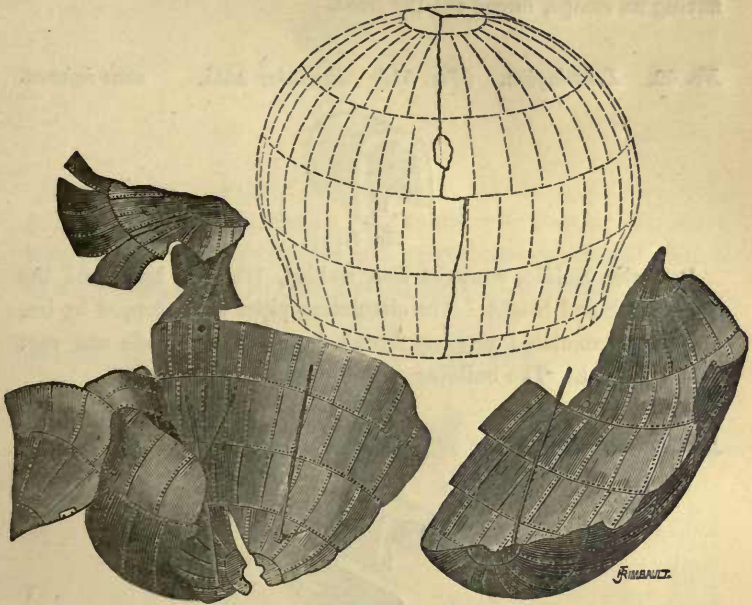
Fig. 49.

No. 60. *Hanley.* (Fig. 49.) *December 16th.* 1 killed, 5 injured.

One of two. Balloon, 30 years old, 15ft. diameter, $\frac{3}{8}$ inch plates, worked at 20 lbs. pressure. It rent in two and threw down the engine house and chimney. The boiler was not intended to work at more than 5 lbs. pressure, and was quite unable to bear the extra pressure to which it was exposed.

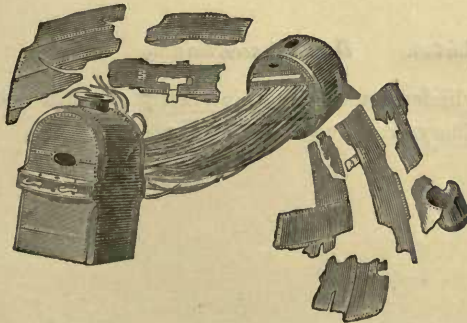
Fig. 56.

No. 67. Northallerton. (Fig. 56.) December 29th.

Locomotive, 20 years old, 12ft. 9in. long, with plates arranged lengthways, 3ft. 8in. diameter, $\frac{3}{8}$ inch plates, 80 lbs. pressure. The barrel appears to have given way on the under side near fire box, and opened out and rent into fragments. As the pieces containing the probable first rent were missing, nothing positive could be ascertained. It may have contributed to the rupture that the engine drew from the fire box instead of from the frame.

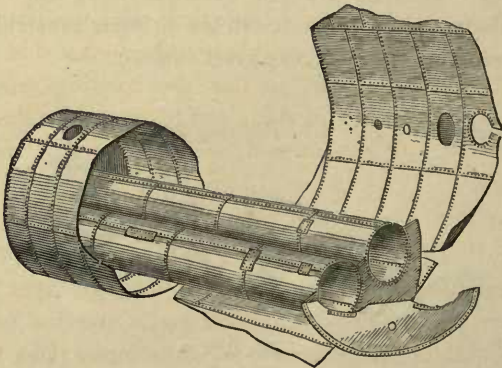
Fig. 4.

No. 5. *Stirchley.* (*Fig. 4.*) *January 9th.* *1 killed, 4 injured.*

One of five, about 30 years old. Lancashire, 18ft. 2in. long,

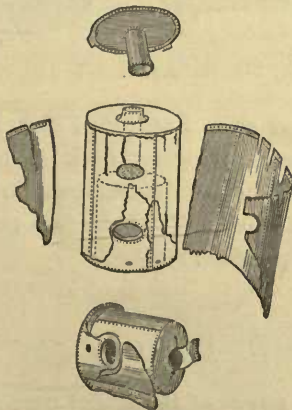
Fig. 8.

No. 16. Birmingham. (Fig. 8.) February 15th.

One of two, 1 year old. Portable upright, 6ft. high, 3ft. diameter,

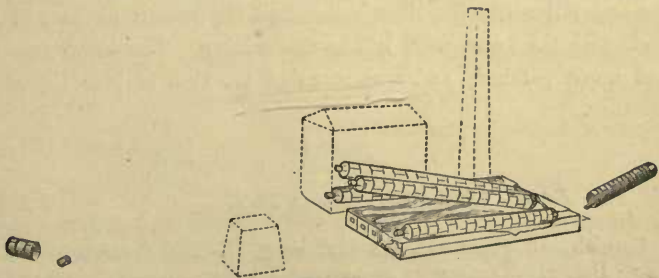
Fig. 12.

No. 22. *Brigg.* (Fig. 12.) *March 17th.* 1 killed, 1 injured.

One of five, 5 years old. Plain cylinder, 68ft. long, 4ft. 4in.

diameter, plates $\frac{5}{16}$ inch full, 65 lbs. pressure. Heated by gas. Rent at fourth seam, the front end being thrown a great distance forward, and the back end to the rear, displacing the other 4 boilers. The ruptured seam was next to a patch where the cutting out of the old rivets and putting in of new had caused a seam-rip.

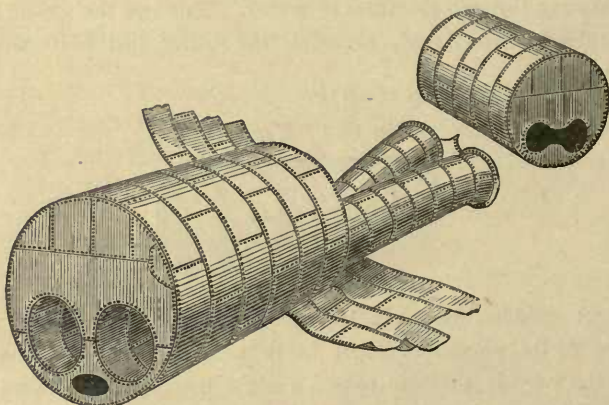
Fig. 13.

No. 23. *S. Wales.* (Fig. 13.) *March 18th.* *none injured.*

One of two, 36 years old. Lancashire, 30ft. long, 9ft. diameter. Tubes 3ft. diameter, $\frac{1}{2}$ inch plates, 22 lbs. pressure. The boiler was rent into 3 pieces. Five rings of the back part were torn off and thrown to the rear. Four rings in the middle were opened out flat and fell across the other boiler, and the remaining part of the shell with the tubes were left on the seating. The boiler was old and much patched, and was corroded too thin to bear the usual pressure.

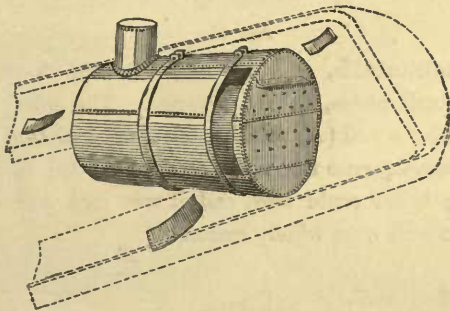
Fig. 15.

No. 25. *Northwich.* (Fig. 15.) *May 3rd.* 1 killed, 1 injured.

Marine, 7 years old, 9ft. 2in. long, 6ft. 1in. diameter. Furnace tube 2ft. diameter, and 3 inch small tubes, $\frac{3}{8}$ inch plates, 81 lbs. pressure. There were two bands as clips round the outside of boiler. Gave way at a seam where some new bottom plates had been inserted, and where the old plate was so thinned by internal corrosion as to be unable to bear the usual pressure. A small plate was blown out and shattered into three pieces, and the boiler was turned end for end.

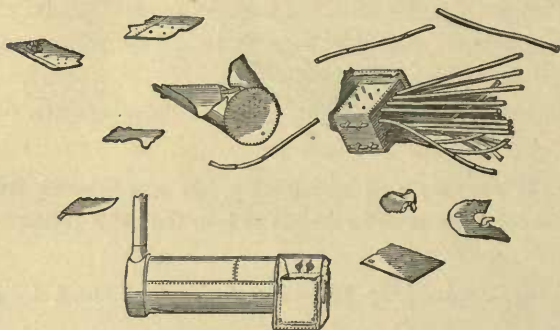
Fig. 16.

No. 27. *Leamington.* (Fig. 16.) *May 18th.* 1 killed, 2 injured.

Portable multitubular, 9 years old, 8ft. 6in. long, 2ft. 6in. diameter, $\frac{5}{8}$ inch plates, 50 lbs. pressure. The safety valve was fastened down by a nail (A) between the lever and the cover, and in consequence the pressure accumulated to more than the boiler could bear, and it was rent into many pieces, which were widely scattered.

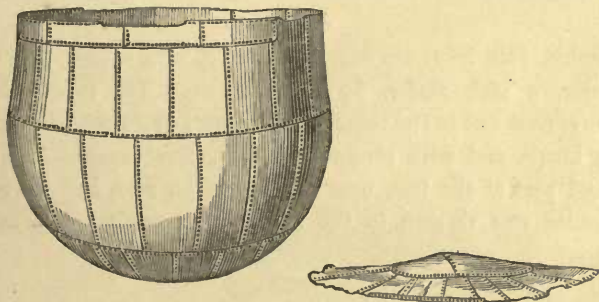
Fig. 18.

No. 31. Oakengates. (Fig. 18.) June 6th. none injured.

One of two, 20 years old. Balloon, 14ft. diameter, $\frac{3}{8}$ inch plates, 6 lbs. pressure. The pressure was allowed to far exceed the proper height during a temporary stoppage of the engine, and the bottom was rent off, and the top thrown some distance, but very little damage was done.

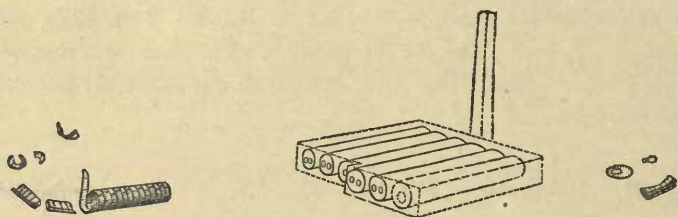
Fig. 20.

No. 33. *Tunstal.* (Fig. 20). *June 28th.* 8 killed, 20 injured.

Cornish, 43ft. long, 6ft. 6in. diameter, $\frac{7}{16}$ inch plates. Tube 3ft. diameter, $\frac{3}{8}$ inch plates, 50 lbs. pressure. The tube collapsed sideways from end to end through weakness, being without strengthening hoops, and with continuous longitudinal seams. The back end and part of the tube were thrown to the rear, and the rest of the boiler was thrown to the front, and separated into several fragments.

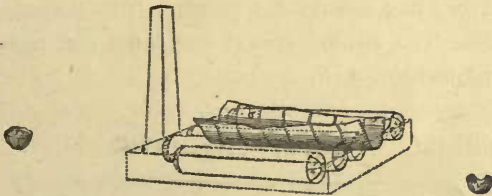
Fig. 22.

No. 37. *Cumnock. (Fig. 22.) July 28th.* *1 injured.*

One of five, about 20 years old. Plain cylinder, 20ft. long, 4ft. diameter, $\frac{5}{16}$ inch plates, 45 lbs. pressure. The boiler had been much patched and altered, and was in very poor condition, and unfit to bear safely the ordinary pressure. Rupture commenced near the feed pipe, and ran along one side and then round each end, both of which were liberated and thrown far away, the barrel of the boiler spreading out on to the neighbouring boilers, one of which was much injured.

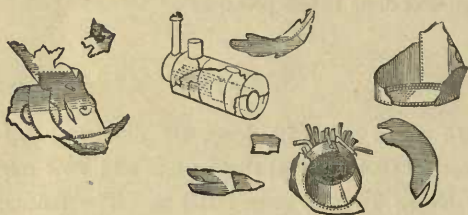
Fig. 23.

several pieces which were much scattered. The safety valve was defective, and the boiler had been much weakened by many patches,

and was in poor condition and unable to bear the pressure at which it was worked at the time of explosion.

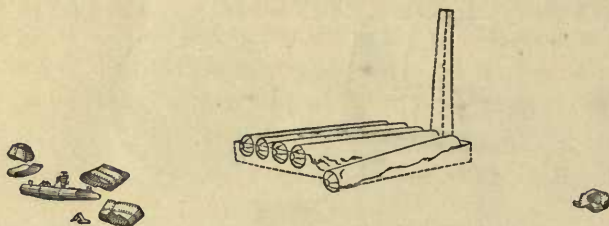
Fig. 27.

No. 45. *Gresley.* (Fig. 27.) *September 2nd.*

One of six, 2 years old. Plain cylinder, 40ft. long, 5ft. diameter, $\frac{3}{8}$ inch plates, 50 lbs. pressure. This case was peculiar, as the back part of the boiler was found a long way to the front, and the front end in the rear. An accumulation of scale caused pocket to form, and a hole to burn through the bottom over the grate, allowing the contents to issue so violently that the boiler was sent over end for end, when the front end was knocked off and thrown to the rear, and the contents then issuing more violently, the reaction sent the rest of the boiler in one piece a great distance to the front, where it fell, and was crushed nearly flat and broken into several fragments.

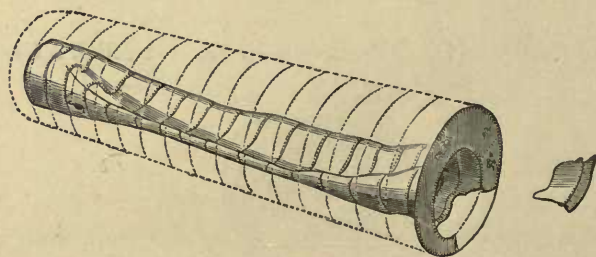
Fig. 28.

No. 46. *Cornwall.* (Fig. 28.) *September 16th.*

One of two, 18 years old. Cornish, 32ft. 9in. long, 6ft. 6in. diameter. Tube 4ft. diameter, $\frac{3}{8}$ inch plates, 45 lbs. pressure. The tube collapsed from end to end, dropping together like an old sack, and cracking at the edges. A small piece at the front end was blown out. The cause was supposed to be shortness of water as

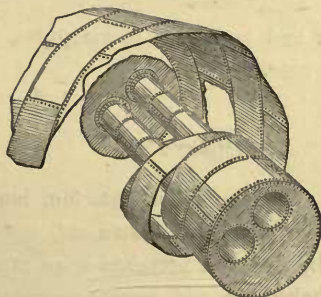
Fig. 30.

No. 48. *Grindleton.* (Fig. 30.) *September 26th.* 1 killed.

Lancashire, 3 years old, 20ft. long, 7ft. diameter. Tube 2ft. 2in. diameter, $\frac{3}{8}$ inch plates, 60 lbs. pressure. The boiler gave way at the second ring of plates from the back end, at the side where externally corroded to a knife edge, by brickwork made damp by being next the side of a hill. The rents extended round the boiler,

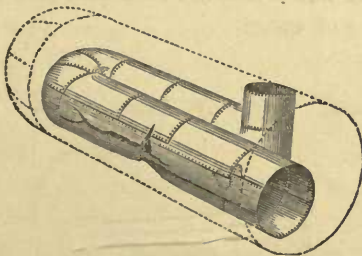
Fig. 32.

No. 55. Bowling. (Fig. 32.) October 30th. 1 killed, 1 injured.

One of two, 17 years old. Marine, 12ft. 7in. long, 6ft. 3in. diameter. Tube 4ft. wide, 2ft 9in. high, 16 lbs. pressure. The tube was much weakened by corrosion and screw-patching and collapsed upwards, with the slightly increased pressure of a temporary stoppage of the engine.

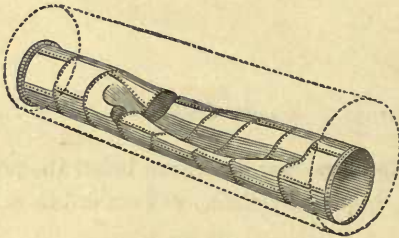
Fig. 33.

No. 57. *Newcastle.* (*Fig. 33.*) *November 5th.* *none injured.*

Cornish, 25ft. long, about 6ft. diameter. Tube 3ft. 6in. diameter, $\frac{3}{8}$ inch plates, 30 lbs. pressure. Tube collapsed from overheating through shortness of water.

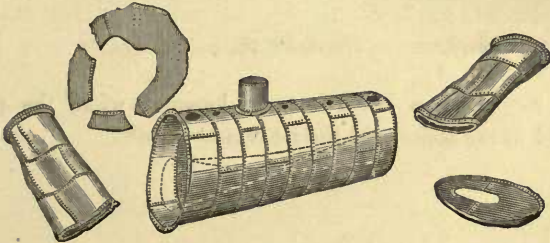
Fig. 35.

No. 59. *Bilston.* (Fig. 35.) *November 12th.* *none injured.*

One of four. Cornish, about 20 years old, 26ft. long, 6ft. 6in. diameter, $\frac{7}{16}$ inch plates, 40 lbs. pressure. Tube 3ft. 9in. diameter had been made in two parts, joined in the centre by a narrow plate $\frac{3}{8}$ inch thick, and it collapsed at this joint, so that the top met the bottom, and thus so retarded the issue of the contents after being set in motion, that a shock was produced, which blew out an end and half the tube in opposite directions. The shell was left resting in its seat, and little damage was done to premises. The tube had much the appearance of collapse from shortness of water, but the most probable cause was that it was too weak without strengthening hoops to bear the ordinary pressure with safety.

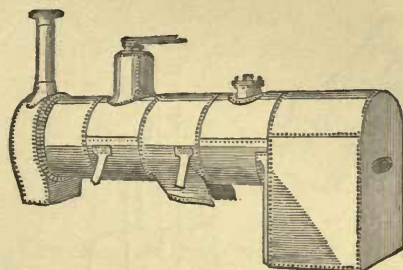
Fig. 37.

the combined action of corrosion and the strain upon the plates, by attachment to the frame of the engine.

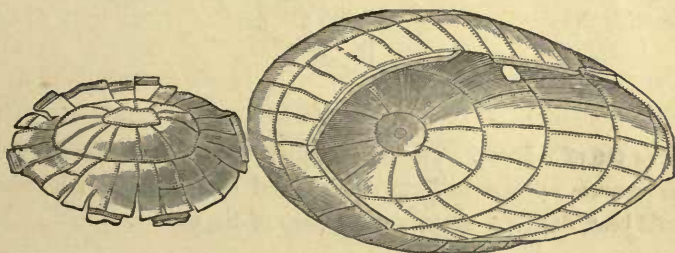
Fig. 38.

No. 65. *Westbromwich.* (Fig. 38.) *December 28th.* 1 injured.

One of five, 23 years old. Balloon, 16ft. diameter, $\frac{3}{8}$ inch plates, 5 lbs. pressure. It ruptured at the back where the plates in contact with brickwork were reduced by external corrosion, and the bottom was forced down upon the grate, and the top rolled over on to its side. The boiler was not being used, although connected with the other at work. The strain upon the bottom was increased by the boiler being over full and nearly to the brim. Those near were drenched with nearly cold water from it when it upset.

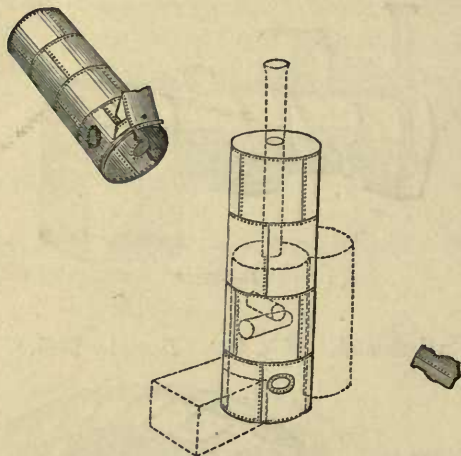
Fig. 39.

No. 66. *Glasgow.* (Fig. 39.) *December 30th.* 11 killed, 30 injured.

where attached to the fire holes and collapsed inwards, and the reaction of the issuing contents forced the boiler up some distance on

to the top of a house. The safety valve did not act properly, and the pressure appears to have accumulated to more than the boiler could bear, during a temporary stoppage of the engine.
